Quarterly Progress Report

September 11 - December 10, 1975

INTEGRATED REAL TIME CONTAMINATION MONITOR

NAS8-31174

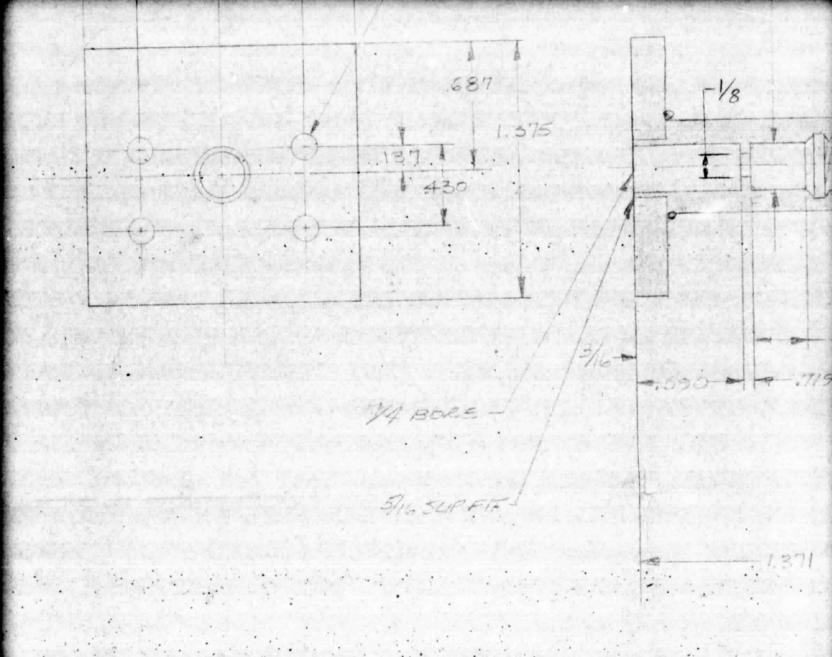
Drawing #11

The Ethylene cylinder with its design features is shown in Figure 11. It is made of Kel-F and proved to be leak proof during all tests.
